System Overview

This troubleshooting guide is designed to help identify and solve potential situations encountered with a 8000/8300 Series Electric Strike. It is not designed as a substitute for the instructions that were shipped with the electric strike. If the instructions are missing, a replacement can be obtained by contacting HES, Inc. at 1.800.626.7590. Information is also available on HES's website: www.hesinnovations.com.

A New Kind of Electric Strike

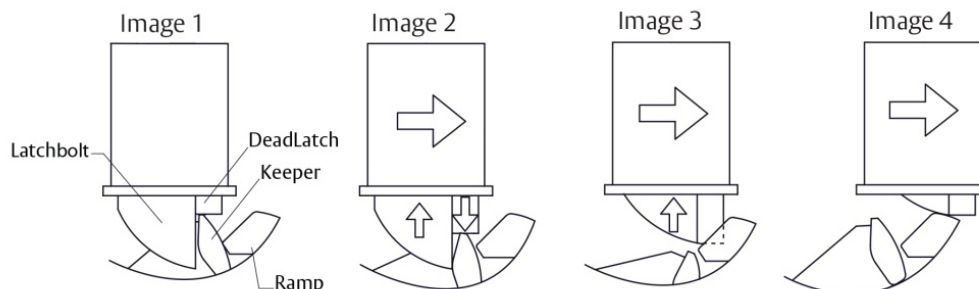
- Initially, the 8000/8300 operates very much like a standard electric strike. With the door in the closed position, the latchbolt is held secure by the keeper (see Image 1).
- When energized, the keeper releases the latchbolt. As the door moves forward, the deadlatch begins to drop (see Image 2).
- As the door continues to move forward, the deadlatch and latchbolt become fully released. The latchbolt will then pass from the keeper and begin to slide up the internal ramps (see Image 3). The deadlatch passes between the two internal ramps without contacting either ramp.
- As the door continues to open, the latchbolt and deadlatch will continue to slide up the internal ramps and out of the door frame to release the door (see Image 4).

A standard electric strike requires a cutout on the side of the door frame to allow the extended latchbolt to exit the frame. In contrast, the 8000/8300 uses special internal ramps to eject the latchbolt from an unmodified frame. For the 8000/8300 to operate correctly, it is important to first understand the relationship between the unit's internal ramps and the position of the latchbolt, as follows:

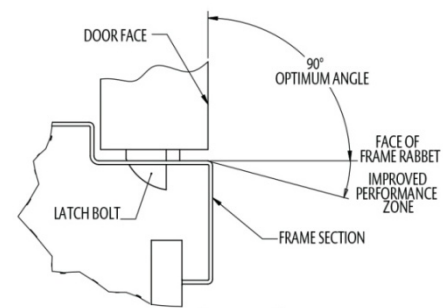
Image 6

1. **IF** trying to determine a measurement of frame twist,
THEN PLACE a carpenter's square on the stop and the face of the door,
AND READ the angle.
2. **IF** the angle is less than 90 degrees,
THEN the 45-degree ramp angle of the 8000/8300 is steepened,
AND CORRECT, as needed (see Image 6).

Although the design of the 8000/8300 provides adjustability to compensate for frame and door irregularities, in some cases, adjusting the frame and door back to industry standards is not an option. The following are some tips to quickly compensate for frame twist and to determine the condition of the latchbolt.

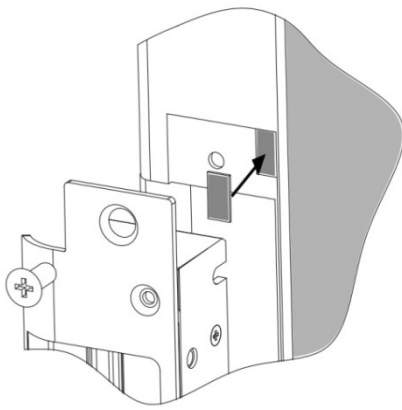
Image 7

1. **IF** manipulating the frame is not possible,
THEN PLACE several shims under the top and bottom (stop side) of the faceplate to increase the 8000/8300 ramp angle and to compensate for frame twist (see Image 7),
OR PLACE shims under the top and bottom (bevel side) of the latchbolt (see Image 8).

When a frame is twisted, the relationship between the face of a closed door and the inside face of the frame (i.e., Rabbet) may not meet the 90 degree industry standard. Untrue frames and doors impact latchbolt wear and the force required to exit. It is recommended that the angle be 90 ~ 95 degrees.

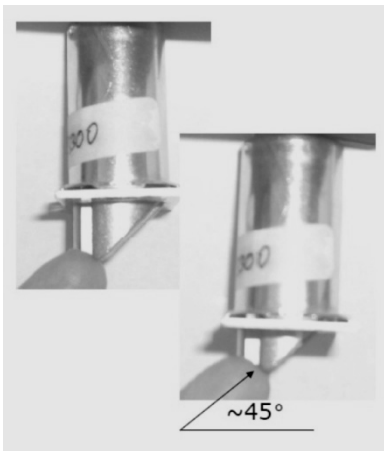
Image 9

NOTE: The finger applying force mimics contact by the ramp.

- a. APPLY force at a 45 degree angle to the latchbolt using a finger (see Image 9).
- b. LOOK for smooth and stable retraction of the latchbolt (i.e., no catching of the latch).

1. PERFORM the Latchbolt Push Test.

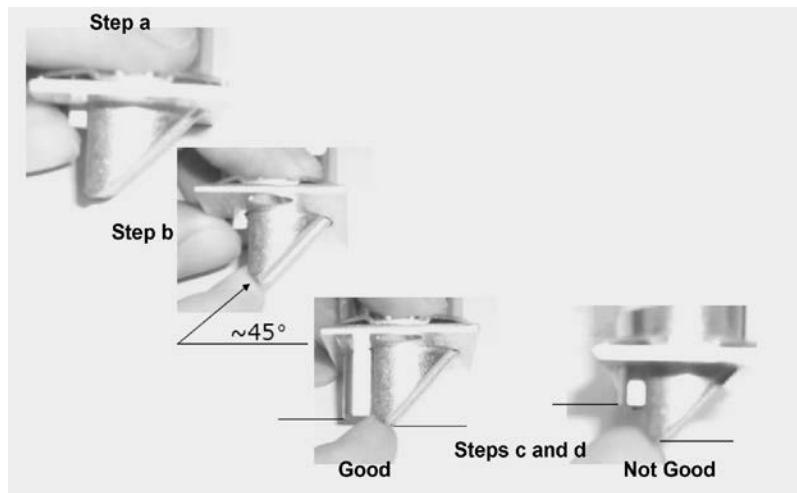
NOTE: Image 10 provides illustration for the following steps.

- a. DEPRESS the deadlatch and HOLD.
- b. APPLY a slight force to the latchbolt at a 45 degree angle (but not enough to move it up).
- c. RELEASE deadlatch.
- d. LOOK for deadlatch to freely drop back down to its unguarded position.

2. PERFORM the Deadlatch Drop Test.
